CASE STUDY

MMAAZZ

‘From breakage to global optimization.’

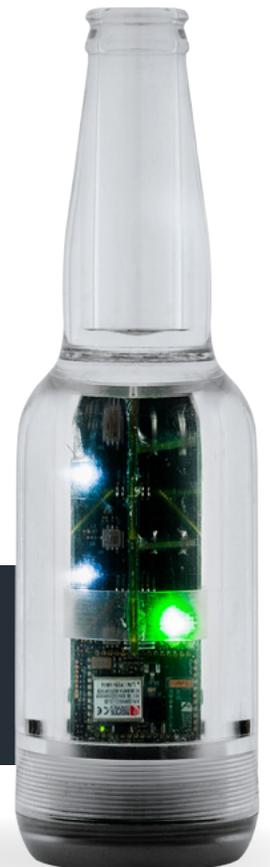
ShockQC™ is a smart replica of glass containers, cans or other fragile containers to measure IPS and G-Force to identify the root cause of damage with 99% repeatability. Location tracking with wireless Bluetooth beacons and integrated photo capture pinpoints the origin of damage and opportunities for improvement as the device travels through the entire filling, capping and packing process.

ShockQC™ (in an acrylic replica of the client’s bottle) was placed on the Carlsberg line and the real-time data from multiple runs left no room for doubt. Breakage was happening near the packer, but the largest impact area was occurring in the de-packer at the beginning of the filling line.

Use of ShockQC™ determined that impacts received by bottles were causing damage on the bottle surface and weakening the glass until other impacts downstream (though small) caused breakage.
